AIRCRAFT RESEARCH AND DEVELOPMENT UNIT

FORMAL REPORT - TASK 0301

AS350BA SQUIRREL HYDRAULICS OUT EVALUATION

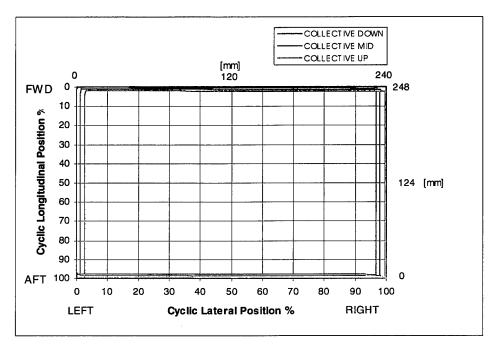
Figure H-3: Cyclic Envelope with Varying Collective Position

- 4.1.3.1. Cyclic Envelope. The cyclic envelope for the hydraulics selected ON with the collective in various positions is presented at annex H, figure 3. The figure shows scales for displacement from the fully forward and left position to the fully aft and right position in percentage and mm. The stick could be moved a maximum of 248 mm longitudinally and 240 mm laterally. A square envelope was noted which was qualitatively assessed in flight with adequate control margins (greater than 10%) existing for the tests conducted hydraulics ON. A variation in the envelope was noted for varying collective positions of up to 3% as shown in the figure. This was due to the effect of the limit stops in the mixing unit for both cyclic and collective as the controls for the main rotor were actuated through the same circuit. The difference was due to mechanisation of the control run. The pilot had no difficulty in reaching the extremes of lateral or longitudinal cyclic travel required for the manoeuvres flown hydraulics ON. The cyclic stick envelope was satisfactory with the hydraulics ON.

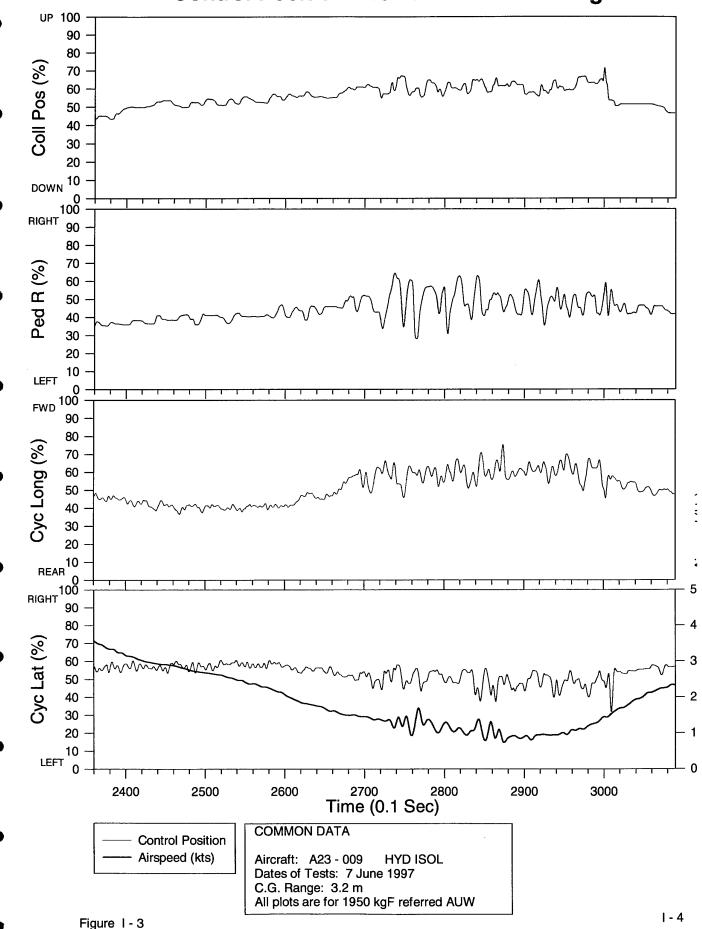
Control Forces - 10 kt Aborted Landing

- Cyclic Hydraulics OUT Freeplay. Figure 3, in annex I shows control positions for a 10 a. Knot running landing attempted at 1950 kg, ISA sea level conditions. The longitudinal cyclic was varying ± 15% and the lateral cyclic was varying ±10% during the attempted touchdown. The reduction in control authority in the cyclic circuit was manifested as system freeplay when changing the input direction of the cyclic lever through the control feedback neutral point (ie the aircraft flight condition where the magnitude of the feedback forces in the cyclic were at a minimum). The freeplay, or dead band of control movement, made precise control in the longitudinal and lateral axes required during hover or running landings below 15 Knots extremely difficult, as constant movement through the freeplay was required before a cyclical pitch change at the rotor head took place. Maximum tolerable pilot work load in the cyclic axes was reached in order to maintain control of the aircraft. This characteristic was another likely contributing factor to the loss of control situation which preceded the aircraft accident on the 10 Mar 97. The cyclic hydraulics OUT freeplay was unacceptable. The recommendation in paragraph 4.1.3.2 also embraces the deficiency highlighted in this sub-paragraph.

- a. **Pedal Hydraulics OUT Freeplay.** Figure 3 in annex I also shows a yaw pedal position plot for the attempted landing at 10 knots. The plot reveals pedal inputs of ±20% which failed to maintain adequate heading control. The reduction in control authority in the pedal circuit also manifested itself as system freeplay when changing the input direction of the pedals. The freeplay differed from the other controls because of the variability of the control feedback neutral point. The freeplay or dead band of control movement made precise control in the yaw axis during low speed flight extremely difficult as constant movement through this freeplay was required before a tail rotor pitch change took place. This complicated yaw control as the freeplay delayed the control response when attempting to counter gusts or change trim conditions. Consequently, heading departures were difficult to prevent and more difficult still to recover. This was highly likely to be an additional contributing factor to the accident on the 10 Mar 97. The pedal hydraulics

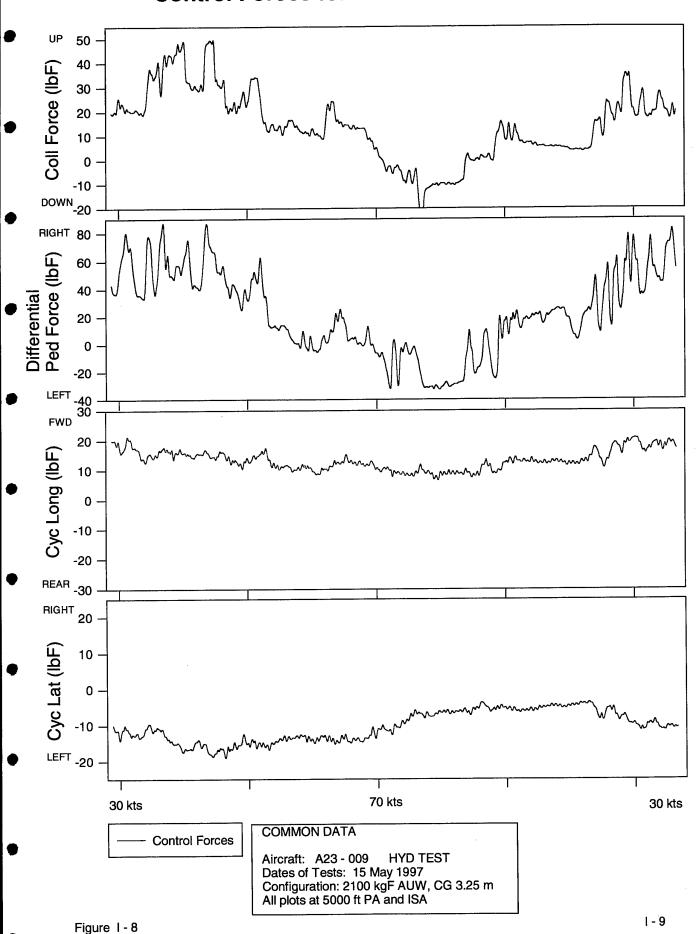
Control Forces for Acceleration - Deceleration

- 4.3.2. Acceleration Deceleration. Plots of control forces during an acceleration-deceleration test at 5000 ft PA, for 1950 kg and 2100 kg are presented in annex I, figure 8. The plots show peak forces of collective at 50 lbf, cyclic at 20 lbf left laterally and 22 lbf forward longitudinally and right pedal at 85 lbf. The aircraft was transitioned over this airspeed range in less than 120 seconds. The 10% control margins were not approached during these tests. The forces for transition were very high but were tolerable as a transient manoeuvre in a degraded mode. Handling qualities during accelerative or decelerative flight hydraulics OUT were satisfactory.
